Earthquake-Induced Ground Fissuring in Foot-Slope Positions of the Port Hills, Christchurch

A thesis

Master of Science in Engineering Geology

University of Canterbury

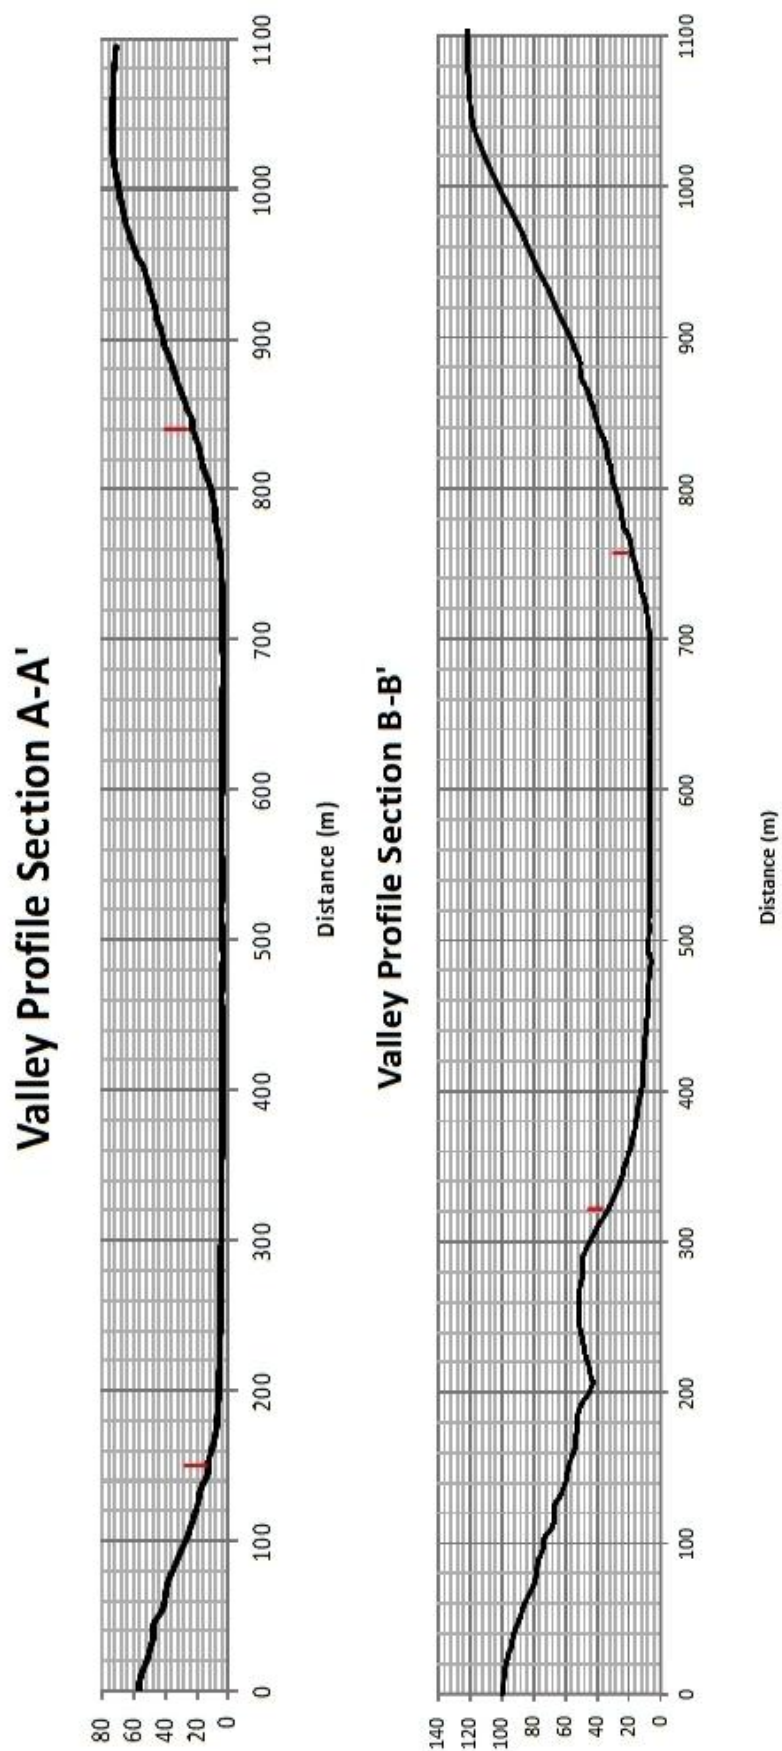
The fissure traces on either side of the valley appeared at similar heights (Figure 4.3), beginning on the western side at the 20 m contour near the southern end of the valley, rising slightly reach the 30 m contour by Glenview Terrace on the west and around 40 Rapaki Road on the east, and then continuing at this elevation with only minor height fluctuations in the order of 5-10 m and a slight gradual decrease in elevation towards the 20 m contour again at their ends near Centaurus Road.

Figure 4.3 Profile sections of the Hillsborough Terrace valley, with location of main fissure trace shown by red dash. Profile endpoints shown in Figure 4.2. Left-axis shows height in metres above sea level.

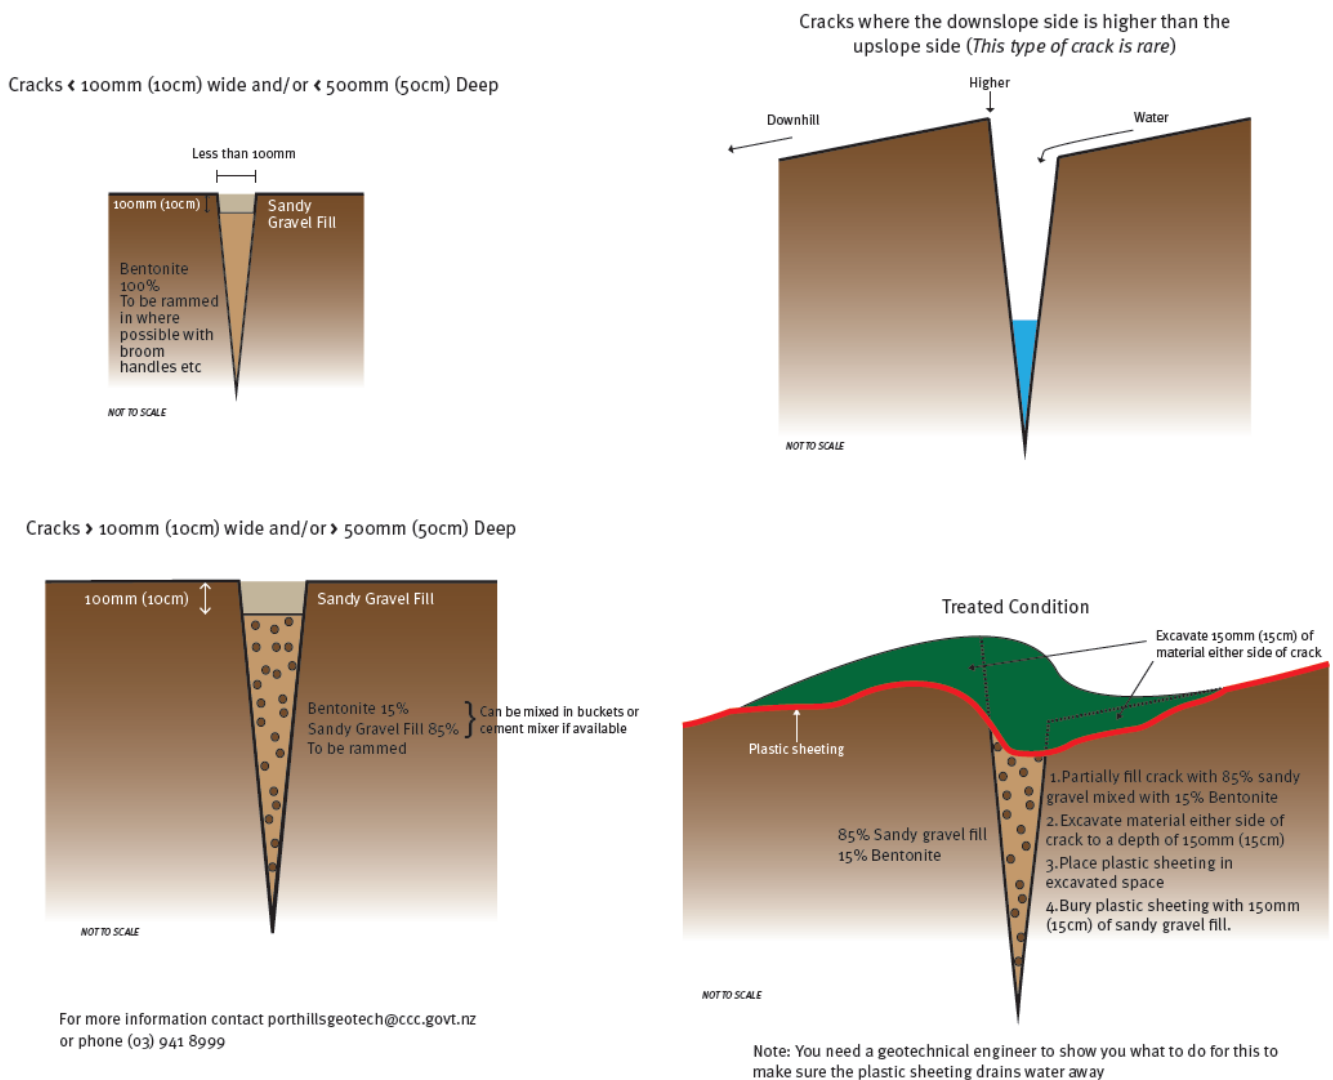
Figure 4.6 Christchurch City Council fact sheet diagrams on the filling of tension cracks. Christchurch City Council, 2011.

It was realised fairly soon after the formation of the fissures in February 2011, that, if left without remediation, they could pose a serious landslide hazard, particularly during the coming winter when heavy rainfall could enter the cracks and lead to extensive tunnel-gully formation or land-sliding. Under the direction of David Bell from Bell Geoconsulting Ltd and James Molloy from GHD, acting for the Port Hills Geotechnical Group, the residents of Vernon Terrace worked together to fill the largest of the fissures over the course of a weekend. They used a 1:6 mixture of bentonite clay (a clay formed by the alteration of volcanic ash, which swells to many times its original volume on contact with water to produce a soft gel (Bell 2007)) and SAP-20 gravel (well-graded, locally-sourced, greywacke gravel with all grains being less than 20 mm diameter). The use of low-permeability bentonite clay was intended to prevent further infiltration of rainwater into the cracks, and as it is a swelling clay, on contact with infiltrating surface water it expanded to fill the fissures over a few days.

In June, 2011, Christchurch City Council and the New Zealand Government produced a two-page guide for filling cracks on the Port Hills. The fact sheet provided information on procurement of bentonite powder and SAP-20 gravel, as well as providing detailed diagrams and practical information on the crack-filling process (Figure 4.6).

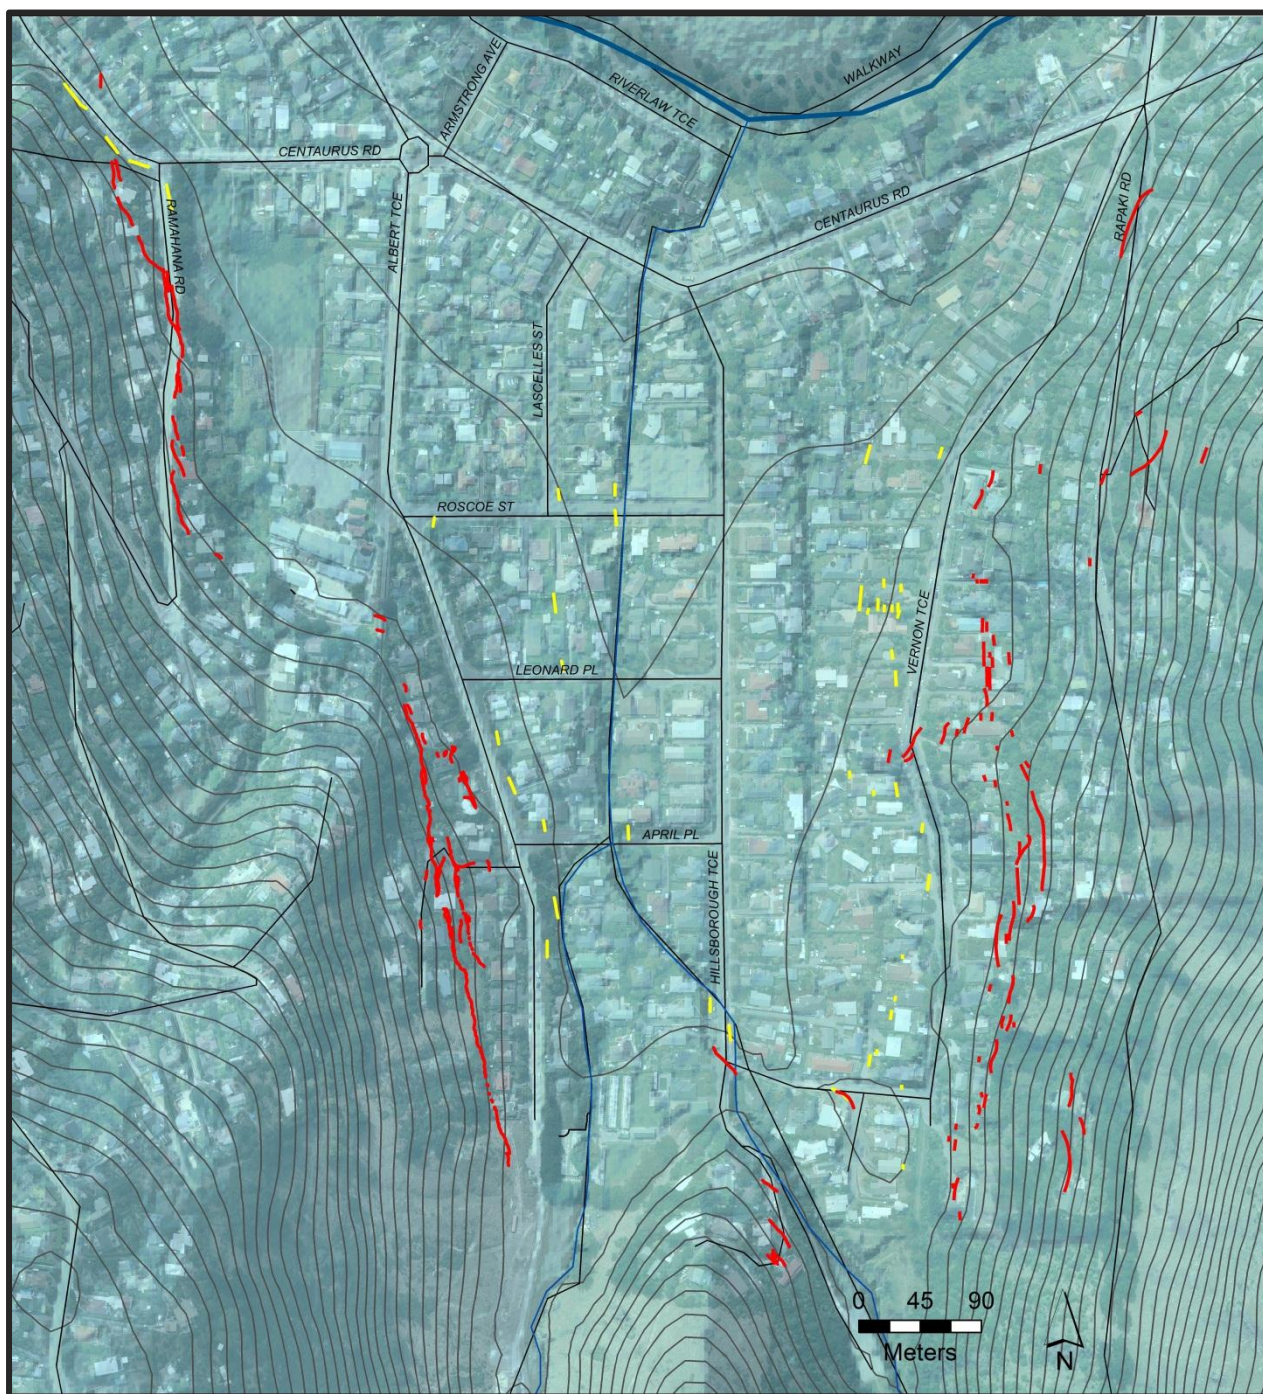
Figure 4.10 Areas of obvious compression in the Hillsborough Terrace valley. Compression features, usually parallel to the fissure trace above, are shown in yellow.

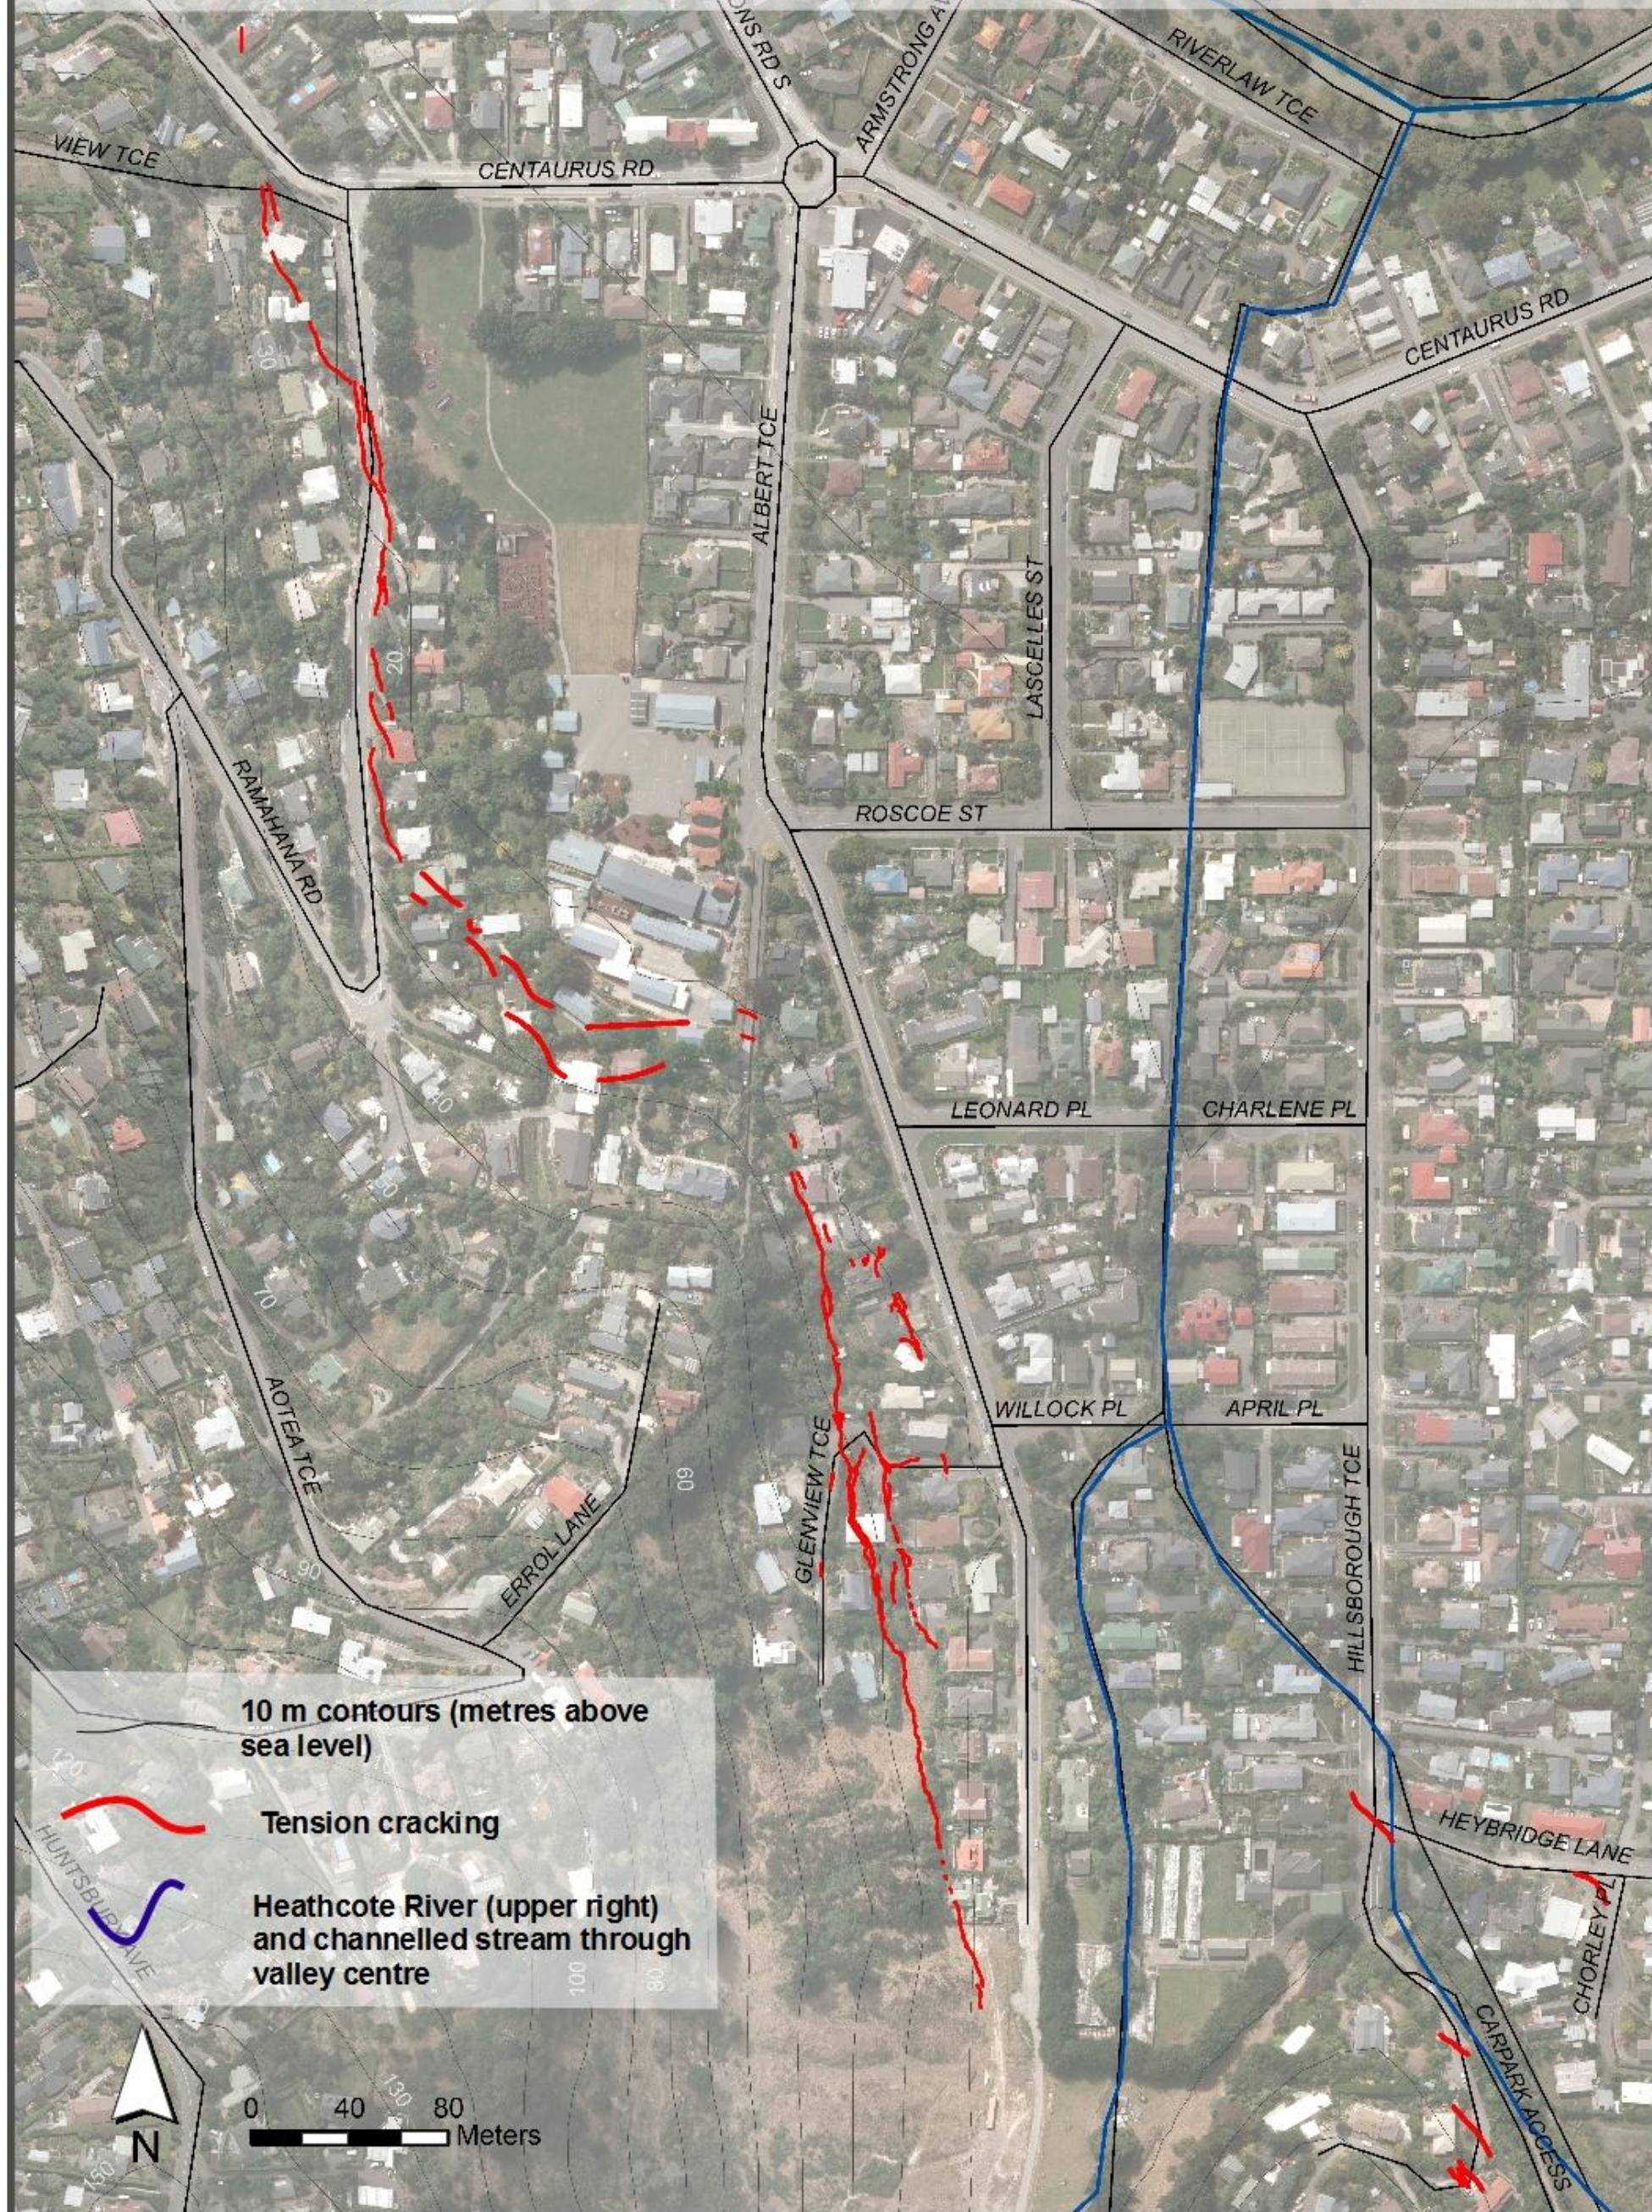
DETAILED TENSION CRACK MAPPING, RAMAHANA RD – ALBERT TCE, HUNTSBURY, CHRISTCHURCH.

Initial site inspections at 3 Glenview Terrace noted that the fissuring passed from this property into the neighbouring section at 1 Glenview Terrace, where they continued directly beneath the house, which was rendered structurally unsound after the Christchurch Earthquake. It was not until later that the lateral extent of the fissures was fully realised. The author undertook detailed mapping of the fissure trace (Figure 4.11), and in attempting to locate the end of the fissure trace, was able to follow it for approximately 600 m, from Centaurus Road in the north, to the end of Albert Terrace in the south (Figure 4.12).

While none of the fissures on either side of the valley are perfectly continuous traces, those on the western side are slightly more continuous than those on the eastern side. While mapping the western fissures the author was able to distinctly observe one larger, more dominant fissure which continued for most of the distance from Centaurus Road to the end of Albert Terrace. In looking at the mapped fissures from the eastern side (mapped by GHD) it is clear that these fissures are of a more discontinuous nature, as well as having a wider coverage of the hillside between the highest and lowest extent of the subsidiary fissures; at its widest, the eastern fissure zone is up to 120 m wide, compared with a maximum width of 70 m on the western side.

Figure 4.11 (over page) Mapped fissure trace from Ramahana Road to Albert Terrace.

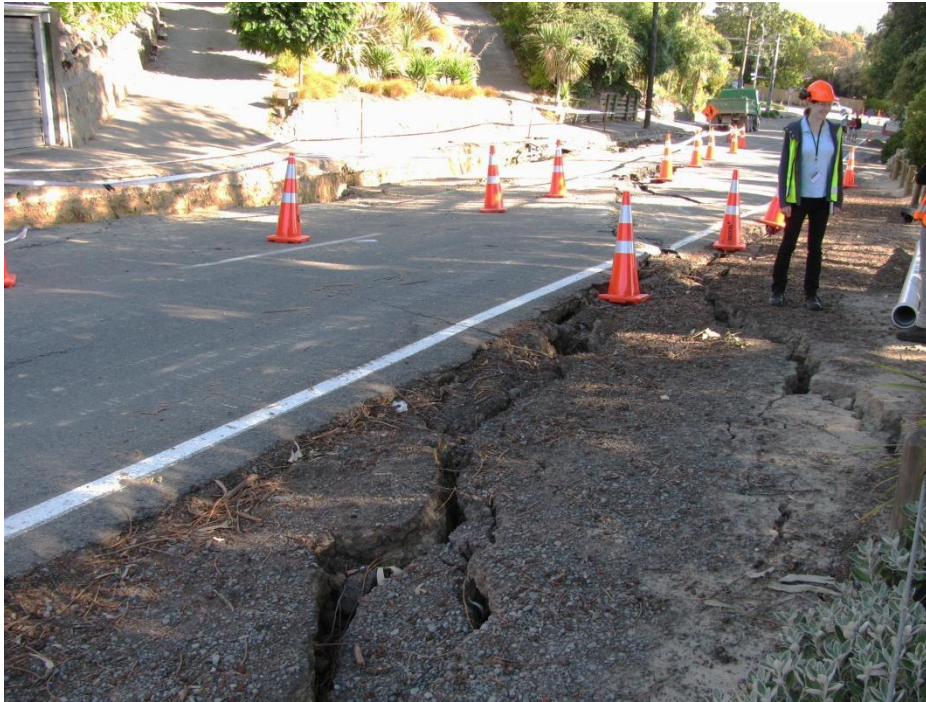
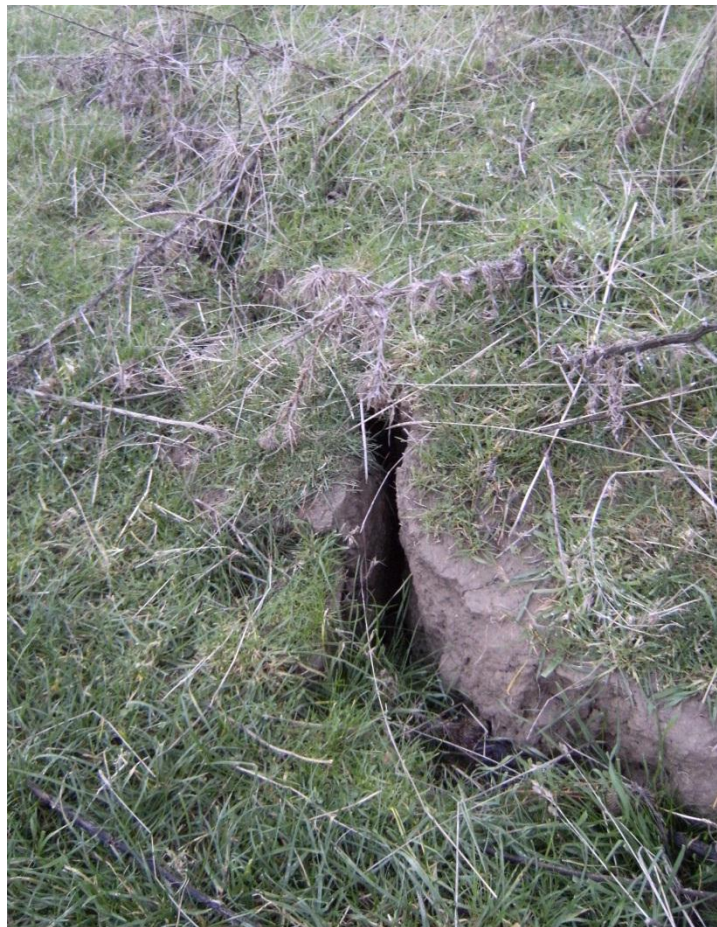
Figure 4.12 Photographs taken at either end of the fissure trace. (a) The author alongside the fissure trace as it crosses Ramahana Road, 50 m south of the Centaurus Road intersection. Photo: J. Claridge. (b) The fissure trace ended in empty sections to the south of Albert Terrace.

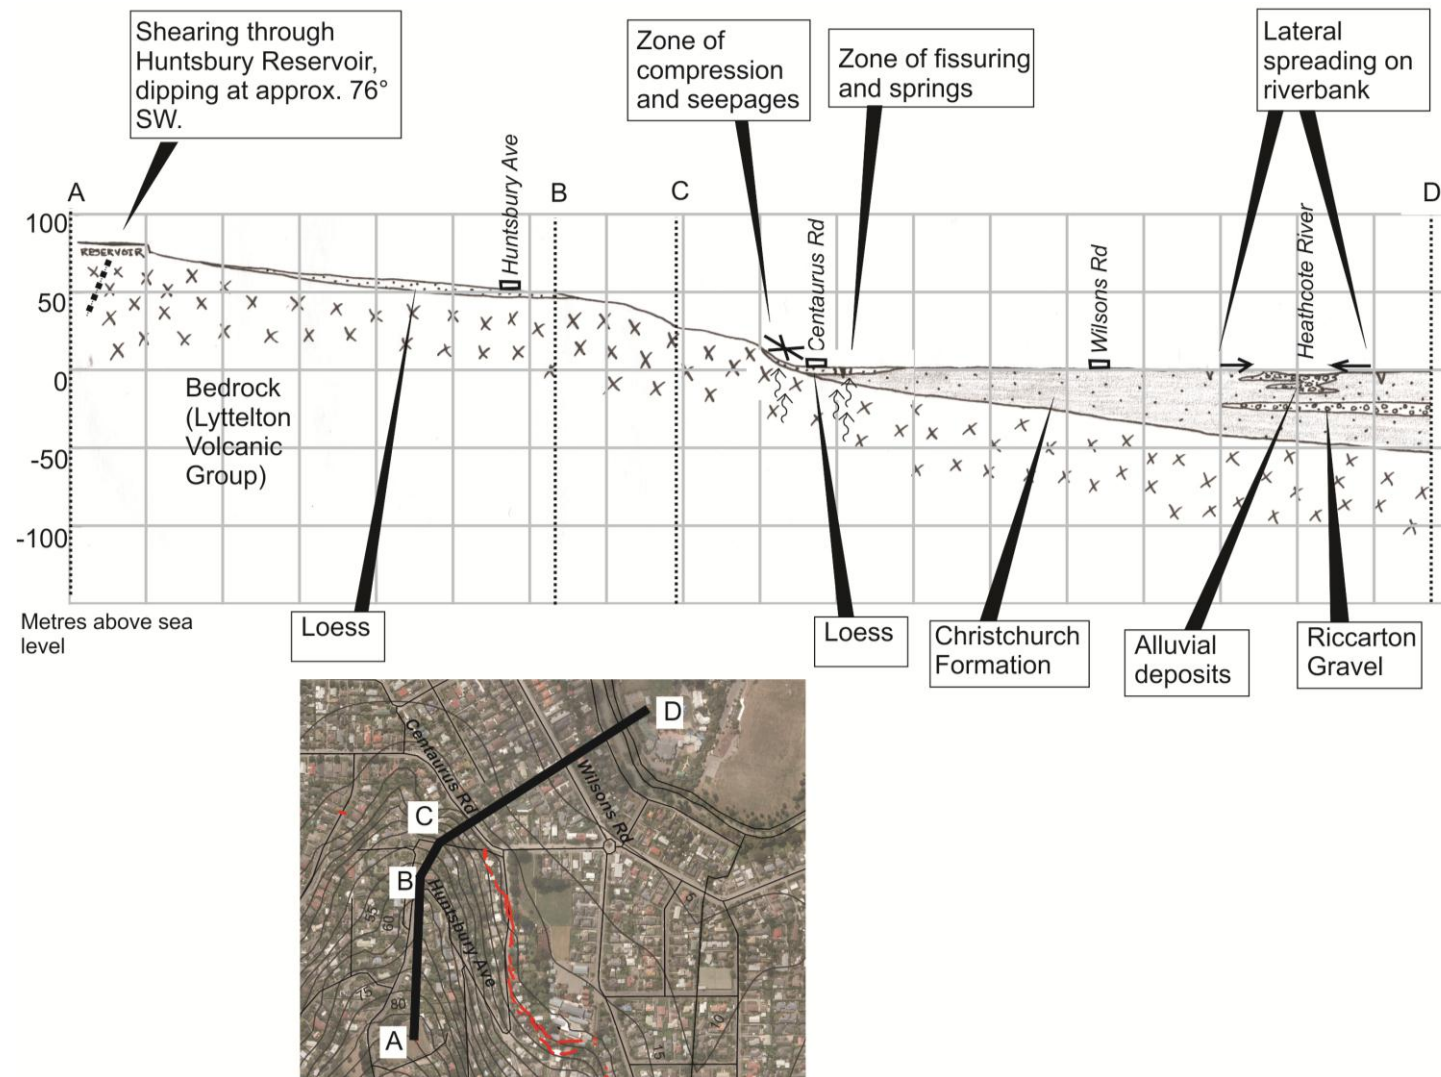
The cross section shows the beginnings of the shearing that was observed below the Huntsbury Reservoir, though it does not attempt to provide possible linking between this fracturing and the fissure and springs below. The fissuring at Centaurus Road is some 10 m in elevation lower than that in the central of the Hillsborough Valley fissures, however it is still apparent that the fissuring is occurring in the foot-slope positions of the hillside in this location, as opposed to the Maffey's Road-La Costa Lane fissures, which occur at higher elevations on the hillside.

Compressional features were observed on Centaurus Road, which in this instance coincided with the seepages, emerging from driveways on the southern side of the road. These, as well as the flowing springs (discussed in more detail in Section 4.7) have also been located on the cross section. The area the cross section passes through at Centaurus Road is unusual in that it is the only site where spring flow and fissuring have been in such close proximity, in fact, the springs below 211 Centaurus Road appear to be emerging from within a fissure itself.

The Heathcote River is some 600 m from Centaurus Road, and is underlain by approximately 50 m of Christchurch Formation silts and sands (Brown & Weeber 1994). At this distance and with such different subsurface circumstances the lateral spreading observed near the Heathcote River does not appear to be related to the fissuring and compression movement near Centaurus Road.

Figure 4.14 Schematic cross section from Huntsbury Reservoir, through fissuring and spring appearance at Centaurus Road, to Heathcote River.

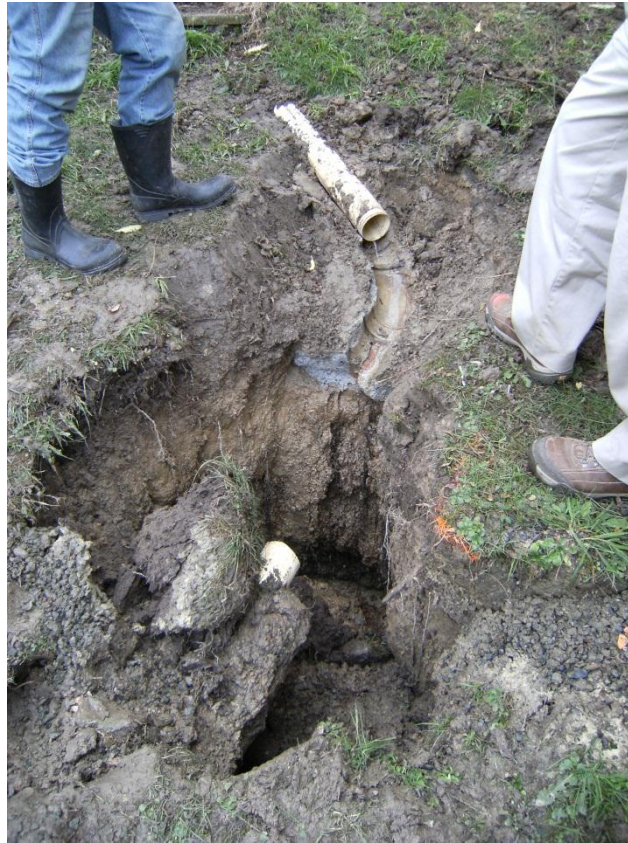
Figure 4.16 The cavity at 3 Glenview Terrace, on July 30th, 2011. Broken drain has been removed back to junction with white pipe shown. Small section of orange dazzle on grass at edge of hole corresponds to dazzle in Figure 4.7. (a) Facing west, fissure trace crossing left to right. (b) Facing north-west, with arrows delineating in-filled fissure trace.

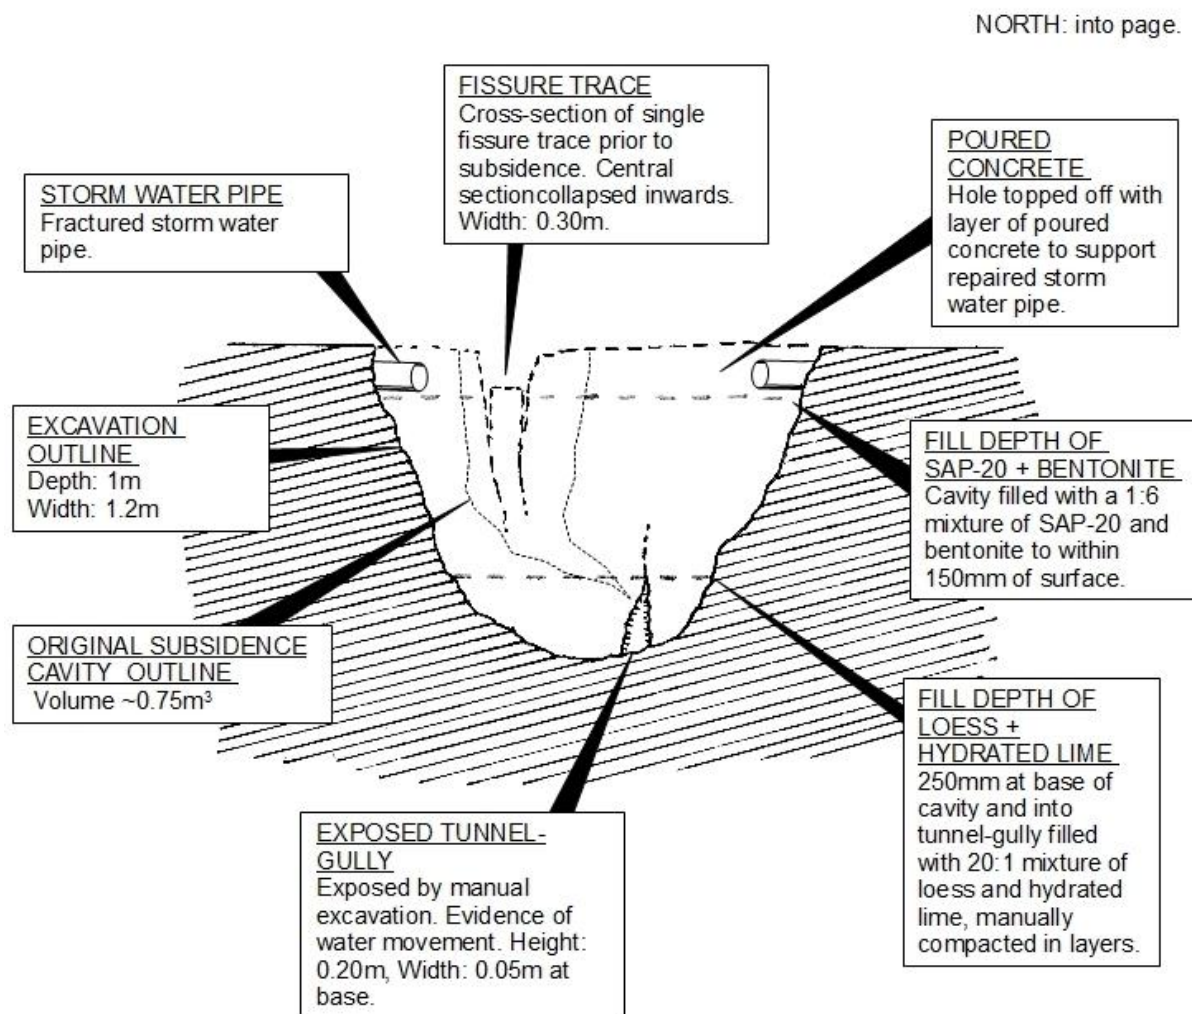
Two days later, on 1 August 2011, the property was again inspected at the request of the owner. Previously he had been advised to excavate the cavity to attempt to locate its base, before filling with suitable materials. Upon attempting this excavation, he exposed a subterranean tunnel-gully (Figure 4.17) on the northern side of the hole, at a depth of approximately 0.60 m below the ground surface. The gully was tall and narrow, tapering at the top to a hairline crack which continued up most of the distance to the ground surface before becoming too small to locate. Its height was approximately 0.20 m, and width, 0.05 m at its base (Figure 4.18). The inner sides of the gully showed undeniable evidence of the regular passage of water, being particularly smoothed over in places. Fine root systems had entered the tunnel, further indicating that this was a regular passage-way for water, as well as providing proof that it had been in place for some time.

Figure 4.18 Schematic diagram of cross-section through subsidence cavity at 3 Glenview Tce and subsequent excavation showing fissuring and relationship to subterranean tunnel-gully system. Storm water pipe flow is from left to right across the diagram.

The base of the excavated cavity, up to a depth of 250 mm, and a short distance into the exposed tunnel-gully, was in-filled with a mixture of loess and hydrated lime at a ratio of 20:1. This mixture was manually compacted in several layers in order to provide a non-erodible base layer, as per the studies on Port Hills loess stabilisation by Bell et al. (1986), Bell (1981), Glassey (1986), and Yetton (1986). This base layer was followed by a water-retarding mixture of bentonite clay and SAP-20 gravel up to within 150 mm of the ground surface. This was the same combination that was used to fill the tension cracks elsewhere. The hole was topped with a layer of concrete which served as a stable base for the drainpipe when it was re-piped across the fissure at a later date. A schematic diagram of the excavation is shown in Figure 4.18.

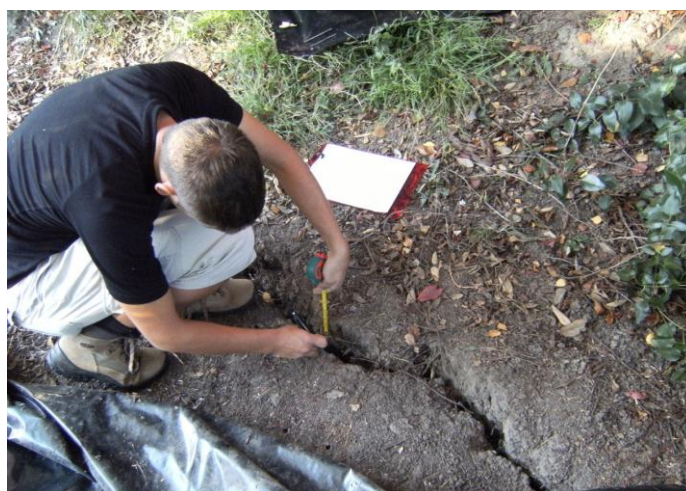
Measurements of the horizontal width, vertical offset and depth of the fissure were taken at multiple sites along the length of the fissure (Figure 4.22). Depth was harder to measure in all places, as the fissures were sometimes slightly curved below ground, and the dry loess of the sides had a tendency to fall inwards. Using a rigid tape measure it was possible, however, to get a good indication of the open fracture depth. This varied greatly across the section at 40 Rapaki Road, with the greatest measurement recorded being 0.70 m, while just 10 m away the fissure tapered closed and for a short distance had no measureable depth. The width of the fissure trace at 40 Rapaki Road was narrower than that observed on the opposite side of the valley at 3 Glenview Terrace. The average width was 70 mm, and the average drop (to the west) was 60 mm.

Figure 4.22 Measuring the vertical offset of the main fissure at 40 Rapaki Road.

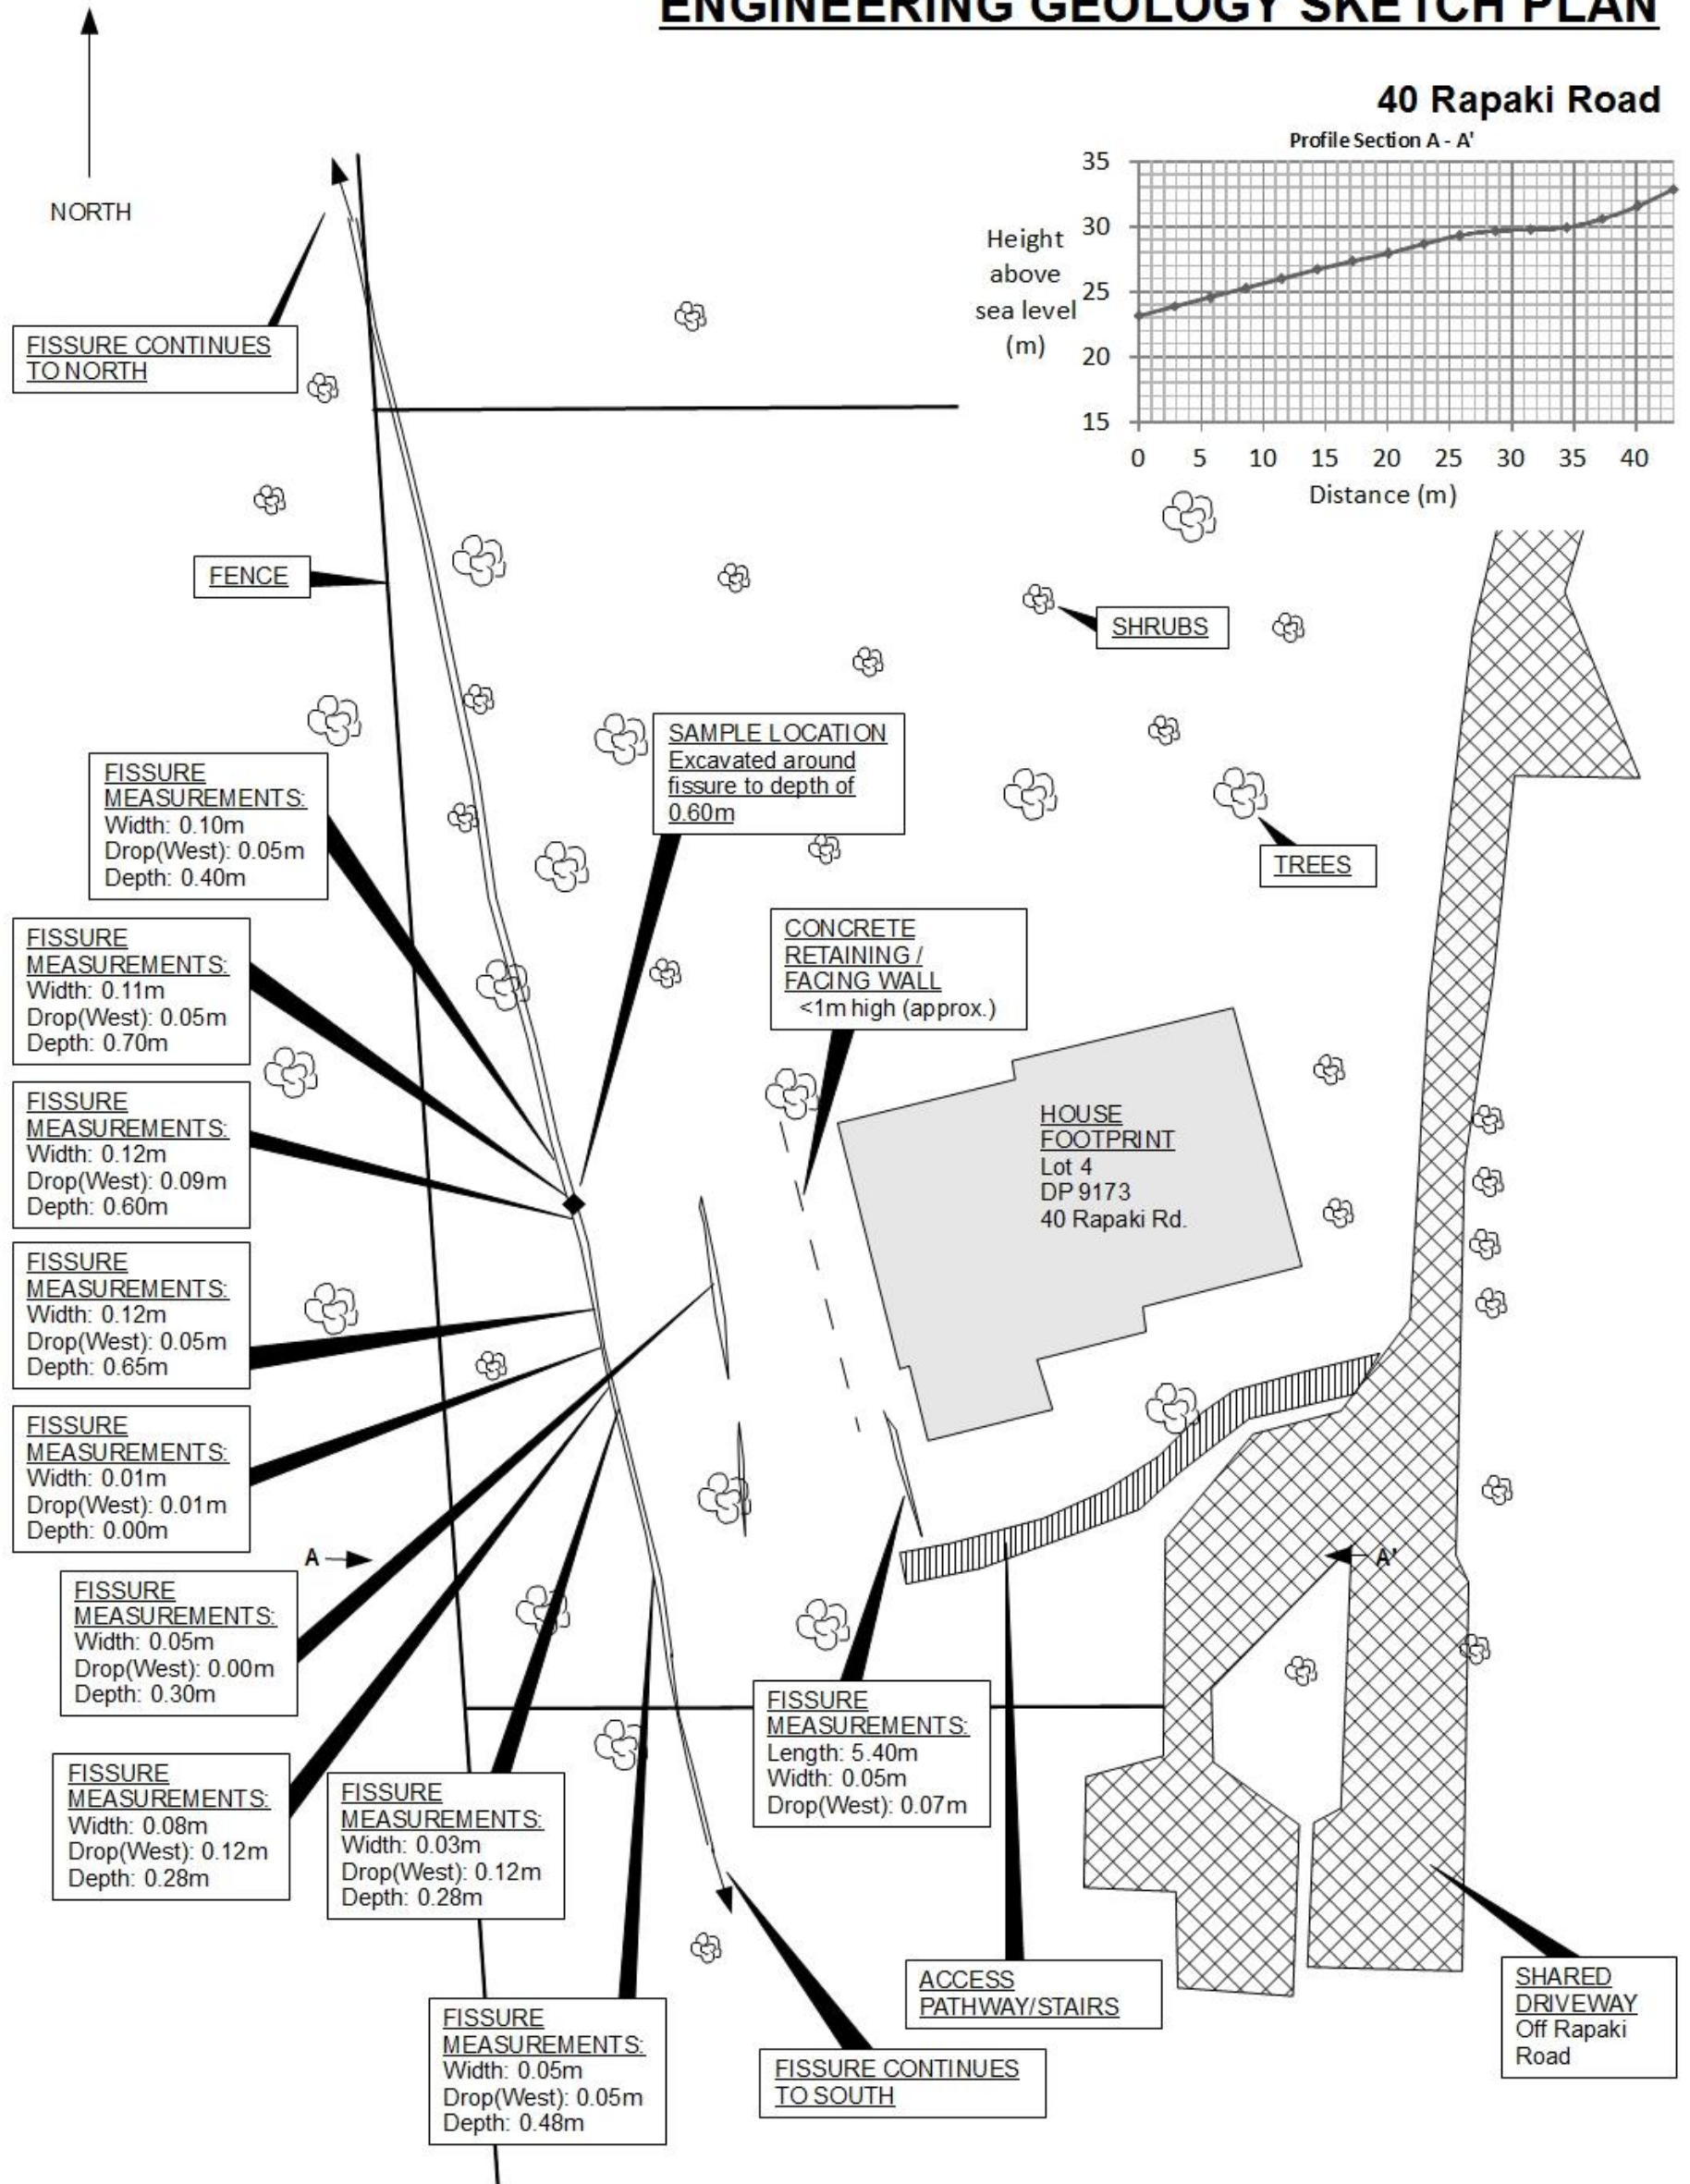
Figure 4.21 (over page) Engineering geology sketch plan of 40 Rapaki Road, Huntsbury.

The main fissure ran in a straight line through the property of 40 Rapaki Road, on an orientation of approximately 320° . There were three subsidiary fissures, at a higher elevation than the main fissure, all trending sub-parallel to the main fissure. These were up to 8 m long, and were distinctly thinner and showed less movement than the main fissure. The main fissure was 0.12 m wide at its widest point, and also had a maximum drop to the west of 0.12 m, however these measurements were not taken from the same location along the fissure. Depth was measured using a metal tape, and was found to be 0.70 m at the deepest point. Depth was harder to ascertain in many places as fragments of the sides of the cracks had a tendency to fall inwards. A detailed engineering geology sketch plan of the site at 40 Rapaki Road is shown in .

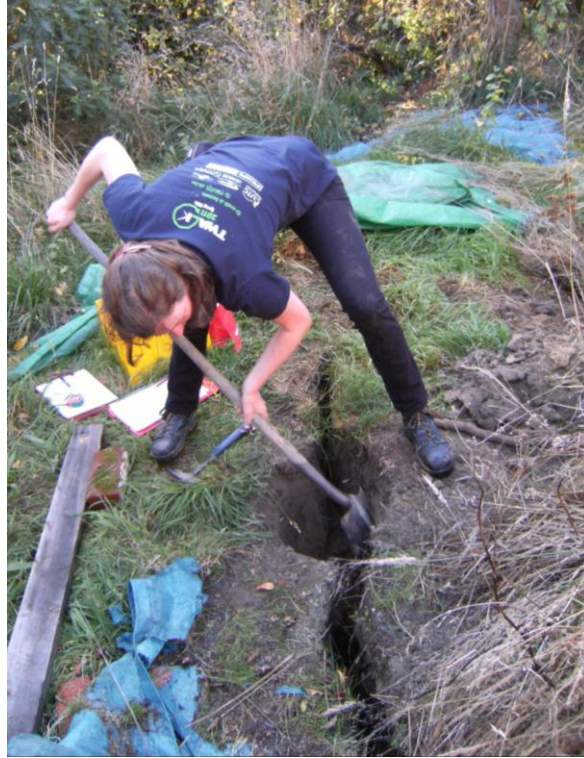
The same push-tube collection and double-bagging method was used to collect loess samples from 40 Rapaki Road on May 13th, 2012. A push-tube sampler was used to collect four short (pinhole) tubes, and four long (density) tubes from a depth of 0.50 m from the largest portion of the fissure, after some further excavation to enable access to a greater depth (Figure 4.23). Bulk loess material was collected from this site as well.

Figure 4.23 Excavating the fissure at 40 Rapaki Road to enable push-tube samples to be taken from a depth of 0.50 m.

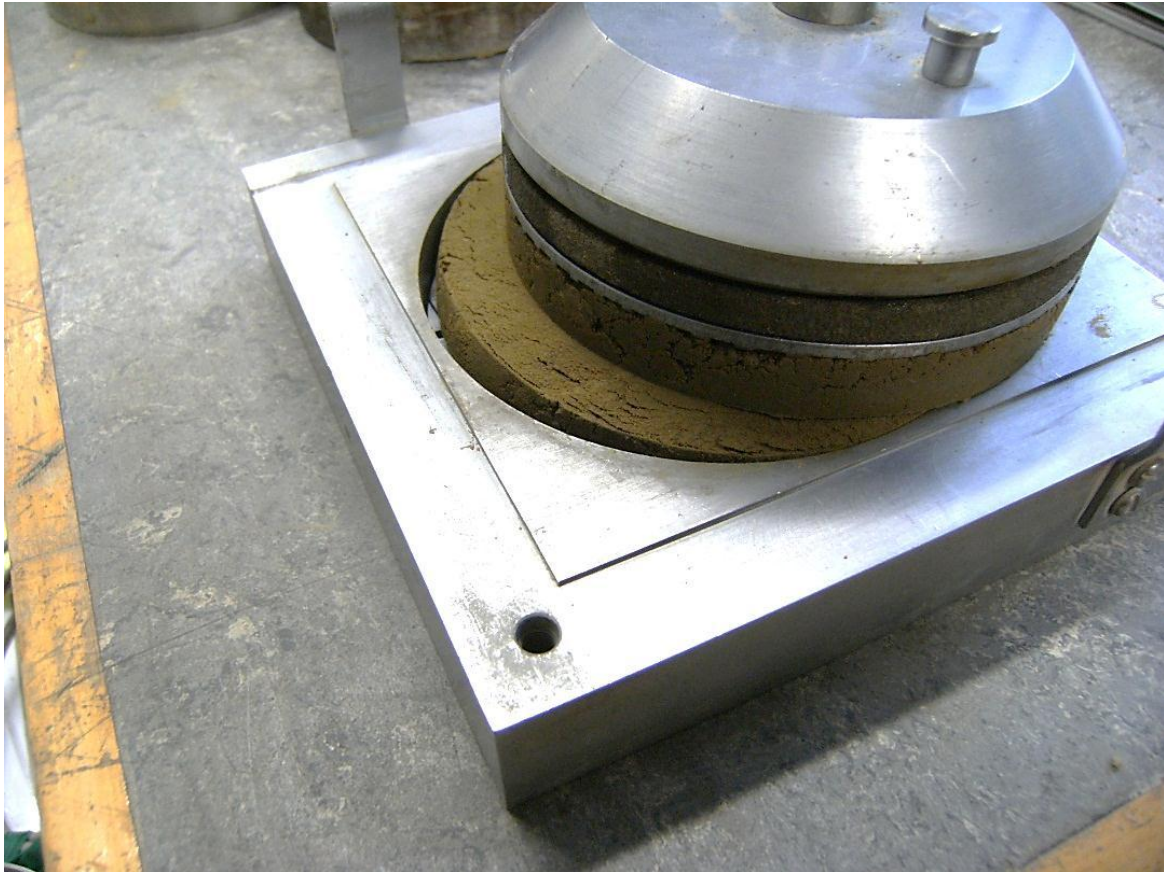
Most samples produced a slightly convex shear plane (Figure 4.28), although removal of the top layer of loess to observe the plane proved difficult. Figure 4.28 shows a sheared sample of Glenview Terrace loess. The direct shear test data was collected by the computer in the form of shear stress over time (equivalent to displacement), and the graphs thus produced are shown in Figure 4.29, Figure 4.30, and Figure 4.31.

Figure 4.28 Completed shear of Glenview Terrace loess.
